PROJECT REPRESENTATIVE'S DAILY REPORT

Pg. 1
Report No. 098
Date: 2015-01-09
Day: Friday

Project: Renovation and Addition to Tewksbury Town Hall

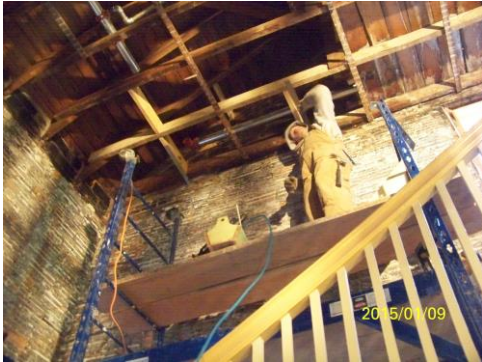
Photo showing carpenter installing tie-backs along the roof line of the main building.

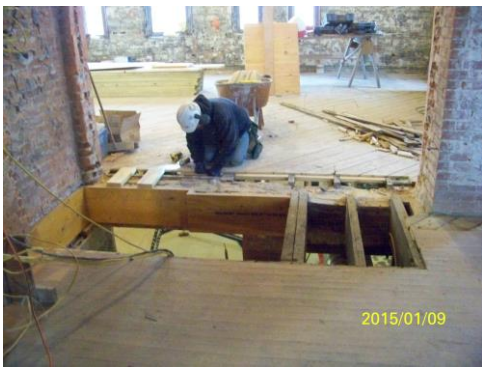
Photo showing carpenter working on the floor lines between the meeting hall and the south wing.

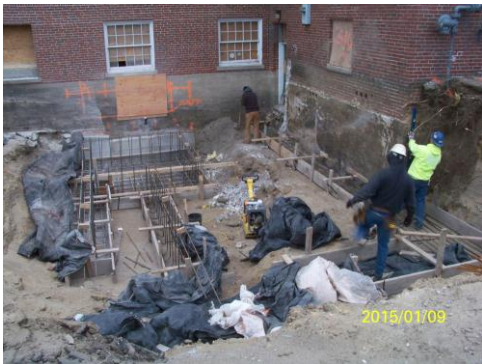
Photo showing crew getting ready for concrete placement for the elevator pit and footings.

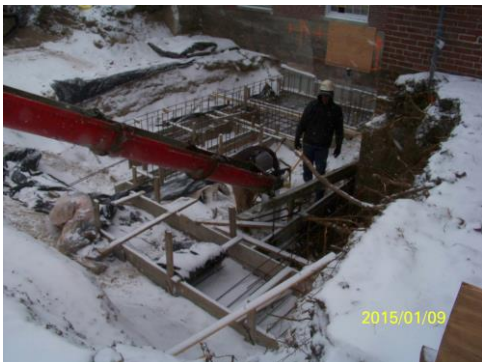
Photo showing concrete being placed.

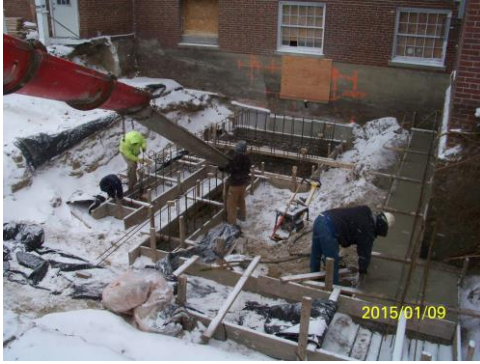
Another photo of concrete placement. The workman to the left of the chute is torching off any moisture prior to the concrete being placed in that section.

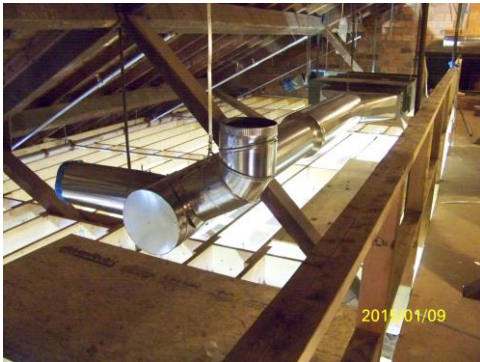
Photo showing more ductwork being installed in the attic.

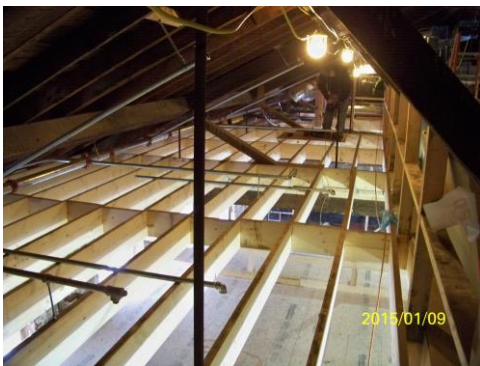
Photo showing the sprinkler lines being installed in the attic.

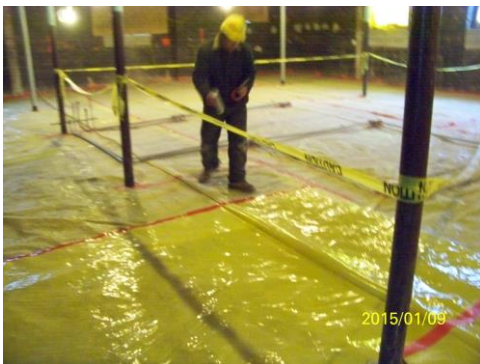
Photo showing the vapor barrier being taped prior to placing the mesh reinforcement.

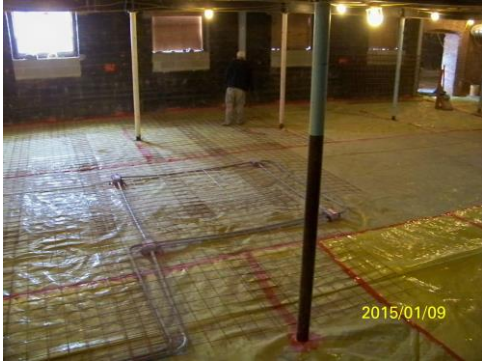
Photo showing the mesh being placed.

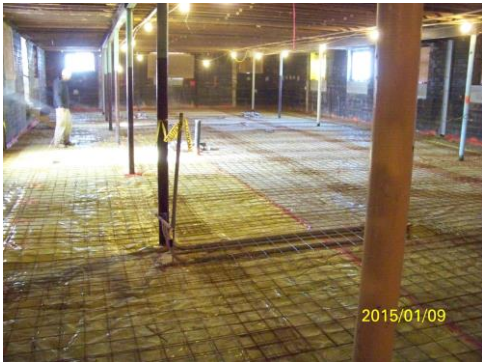
Photo showing the mesh in place and supports being installed.

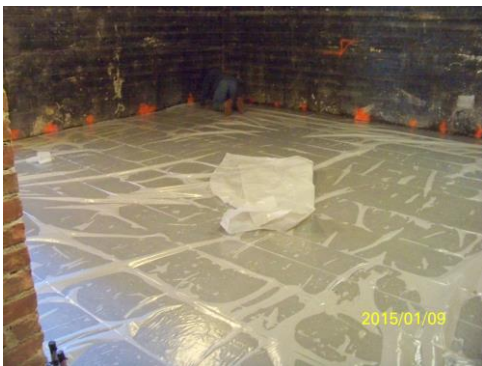
Photo showing workman covering the vault slab after wetting it down for curing.
